DESCRIPTION OF EXPERIMENTS

1.7 THEORY

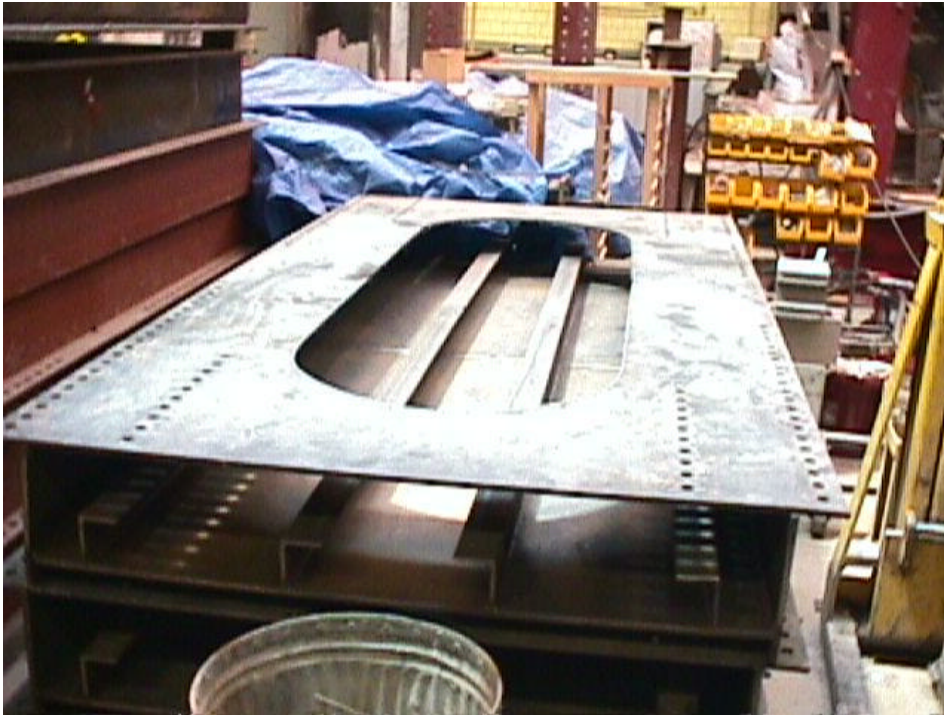
Figure 3-13: Case 4 with viewport cut into middle flange prior to testing.

Case 4 can be seen in Figure 3-13 prior to installation under the support structure. A large opening was cut into the top flanges of the specimens after testing of the baseline case and case 2a because

limited load shedding and negligible displacements were observed with crack growth. The opening also allowed greater access to the interior for crack growth monitoring in the stiffeners.

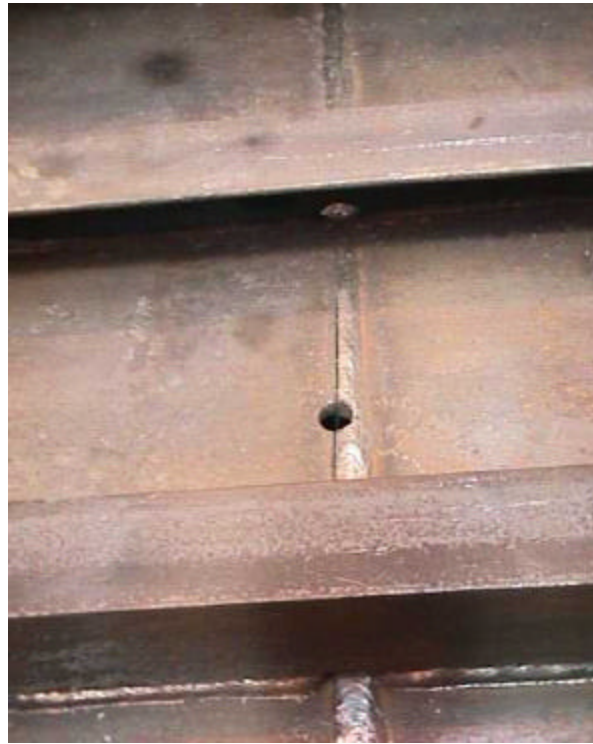
Figure 3-14: Typical initial crack introduced in specimen with reciprocating saw.

Prior to installation under the support structure, the initial crack was cut into the specimens. This initial cut was made by first drilling an access hole for the reciprocating blade and then using the reciprocating saw to cut up to the desired length. At the end of the introduced crack, the saw-cut was beveled through the thickness at a 30-degree angle in order to facilitate the formation of a crack. This initial cut can be seen in Figure 3-14.
